Case Study 2

0.25 W Resistor lead to lead cross wire weld - Monitoring Weld Misalignments

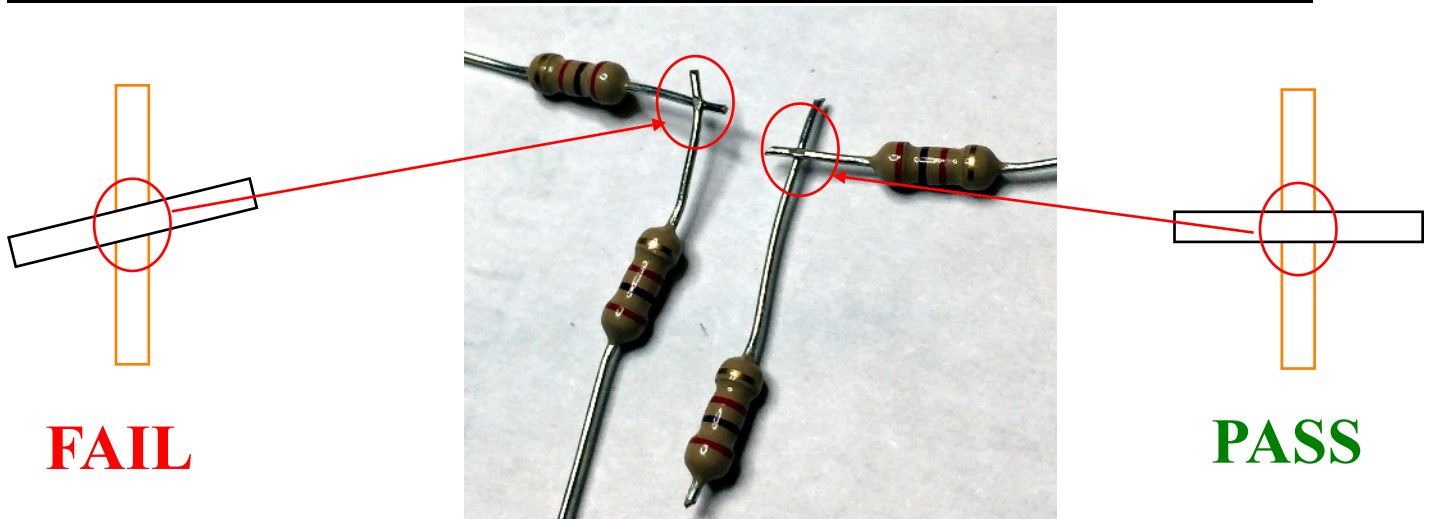
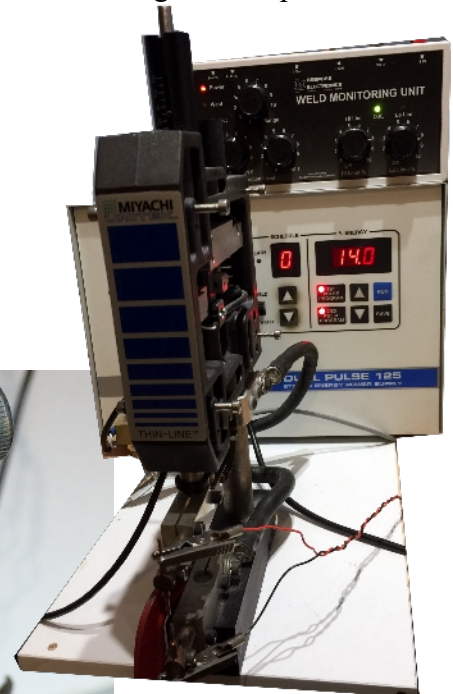
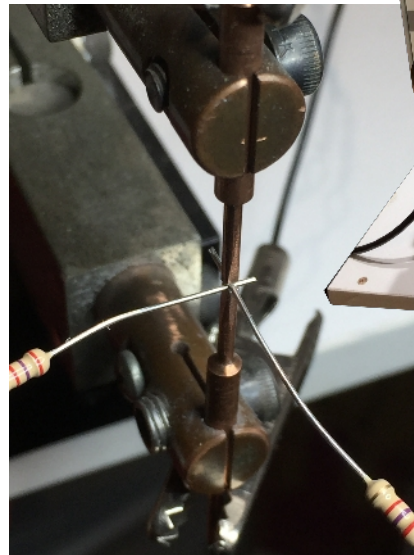
A good weld in this scenario occurs when the resistor legs are perpendicular to each other.

Exploring the sensitivity of the weld monitor in detecting misalignment, we can see that a small angular error in placing the resistor leads one upon the other, leads to a slightly different shape in the weld because there is a slightly different contact and dynamic resistance. **Angular error detection of around +/- 10° is possible.**

The energy at the weld therefore changes and an error is detected by the weld monitoring unit.
